# Manhole Inspection Summary

Manhole # S19C\_\_005MH

Insp Date: **4/24/09 1:39 PM**

**Location** Address: **547 PULASKI ST**

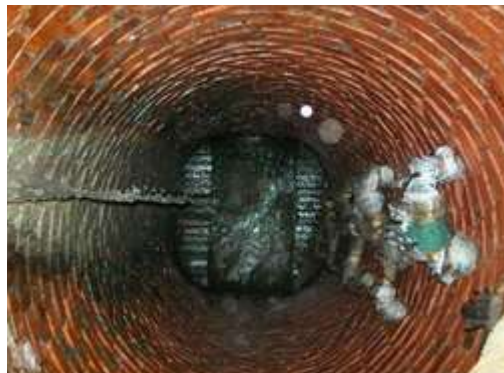
Top View

BETTER VIEW, NOTE DEBRIS ON STEPS MIGHT HAVE COME FROM I9 PIPE CONNECTION

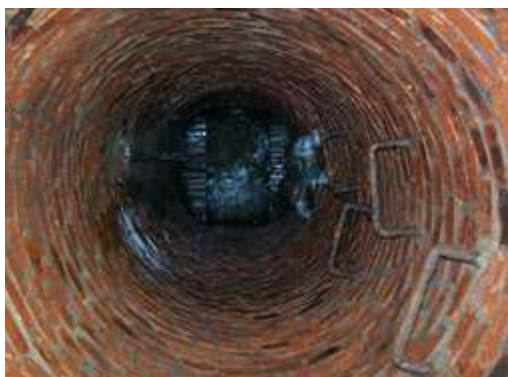
Top View

Count: **14** Missing: **2** ☒ **Corroded**

CORRODED STEPS

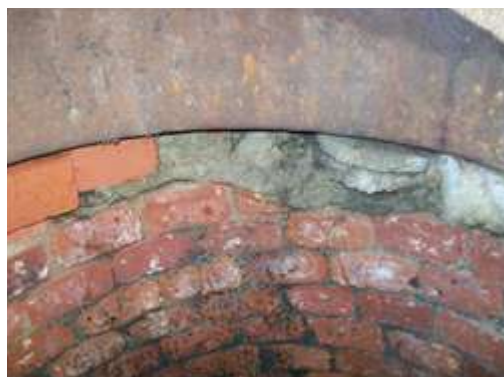
Defect 1

Condition: ☐ Sound ☐ Cracked ☐ Root Intrusion ☒ **Loose Brick** ☐ Deteriorated

LOOSE BRICKS IN CHIMNEY

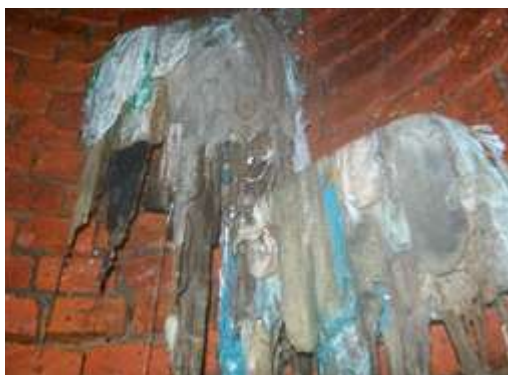
Defect 2

DEBRIS ON CORRODED STEPS  
EVIDENCE OF SURCHARGE

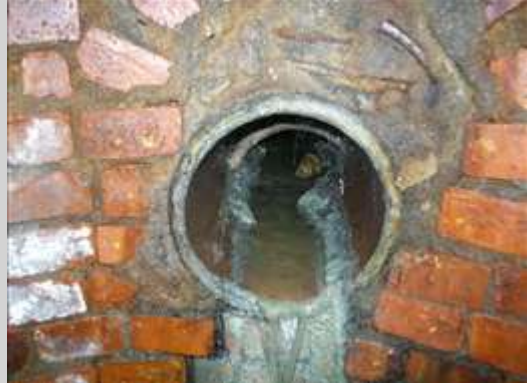
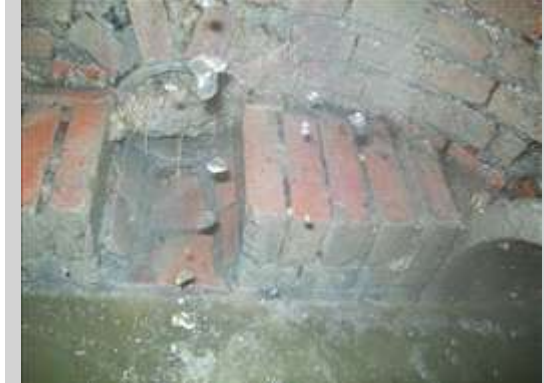
9 O'Clock Inflow

Drop: **Outside Direct**

Drop Condition: **Clogged**
